POND 207A VISUAL INSPECTION REPORT

**ROCKY FLATS PLANT
SOLAR EVAPORATION PONDS
(OPERABLE UNIT NO. 4)**

**U.S. DEPARTMENT OF ENERGY
Rocky Flats Plant
Golden, Colorado**

MARCH 1993

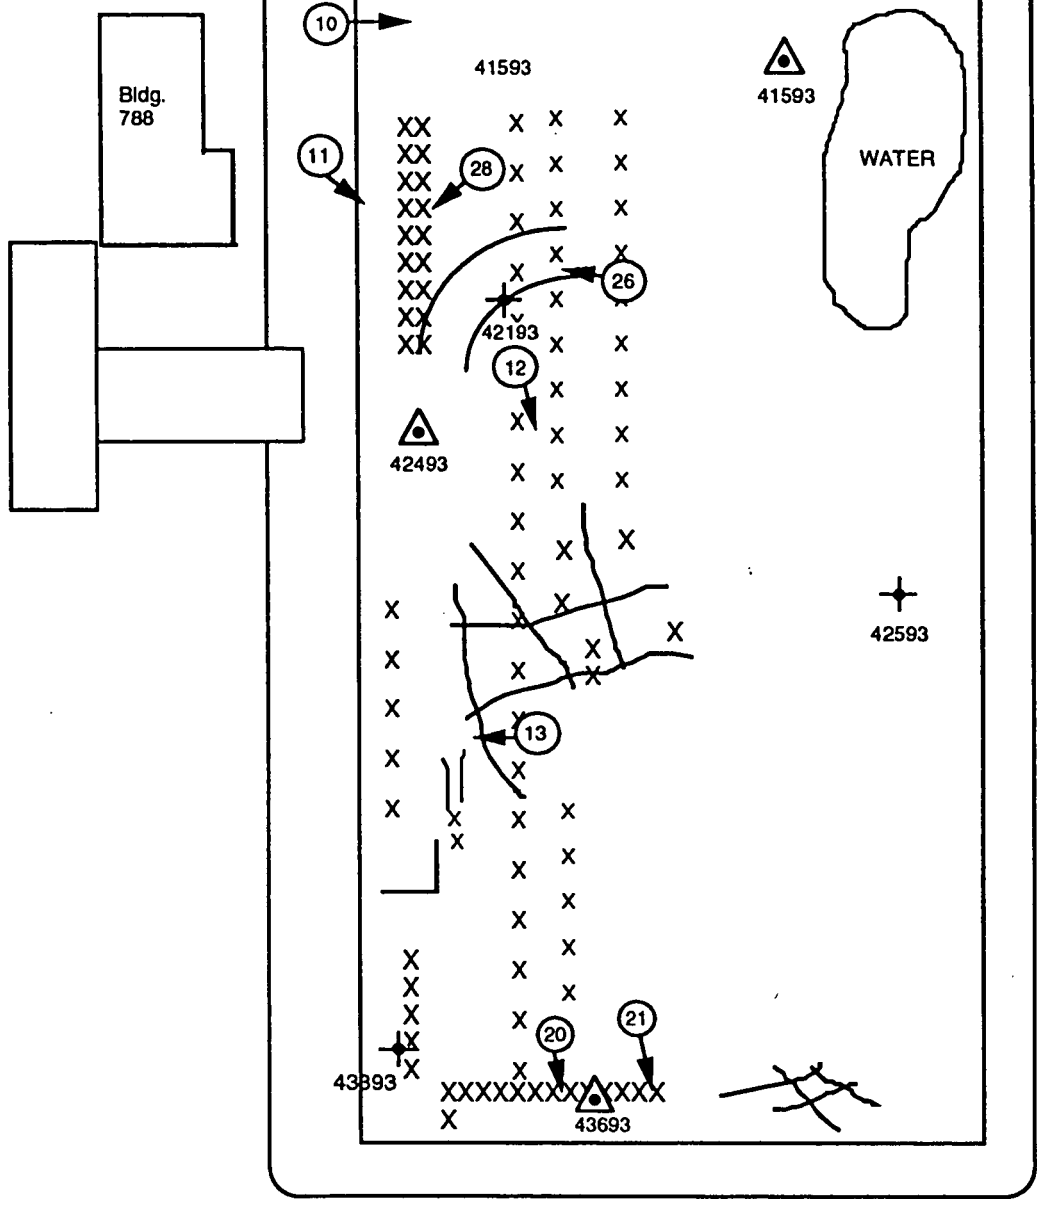
FIGURE 3-1
POND 207A VISUAL
INSPECTION
 DECEMBER 9, 1992 and
 FEBRUARY 26, 1993

Results of the visual surveys are depicted on Figure 3-1. Figure 3-1 is a sketch of the pond which includes approximate locations of cracks, mud-cracked, breached, or bubbled areas, and vantage points from which photographs were taken.

The uppermost layer of pond liner material was observed to be cracked extensively and otherwise deteriorated throughout most of the area inspected. The northeastern one-third of the pond liner exhibiting the least amount of crackling and bubbling, and the western and southern two-thirds of the pond liner and slanting berm slopes exhibiting the most extensive crackling and bubbling. Bubbles and crackling in the liner are believed to be caused by thermal/UV

deterioration during periods when the liner was exposed. Several long continuous cracks were observed in the liner, apparently caused by moving vehicles. Tire track imprints were also observed, but no breaching of the liner was associated with these imprints. Many of the long continuous cracks have deteriorated, causing localized widening and exposing significant portions of the underlying liner. Some of the mud cracks and longer cracks were observed to have soil underneath, although it is unknown if this soil was residual solids in the pond sludge that were unable to be removed during pond cleanout. Mud cracking was observed to be dominant along the slanting berms which had been exposed to the heat of the sun for a longer time.

Borehole locations are specified in the Phase I RFI/RI Work Plan to coincide with cracked and uncracked locations in the liner to investigate the possibility of contaminant migration from the pond sludge and liquids into the subsurface. The visual survey confirmed that there were visibly deteriorated and potentially cracked areas, and the geophysical survey generally confirmed that subsurface deterioration coincided with visual surface deterioration. Based on the visual and geophysical survey, the six proposed borehole locations as shown in OU4 Technical Memorandum No. 1 have been relocated into three of the most damaged locations and into three areas considered to be relatively intact. The resulting borehole locations in Pond 207A are shown on Figure 3-1. These locations supersede those shown in Phase I RFI/RI Work Plan maps and maps in Technical Memorandum No. 1, Vadose Zone Investigation. Relocation of
